**NATIONAL REGISTER OF HISTORIC PLACES
CONTINUATION SHEET**

Yosemite Valley
Property Name

NATIONAL REGISTER OF HISTORIC PLACES NOMINATION FORM

PART III: BUILDING AND STRUCTURE INVENTORY
Supplemental Information for Section 7

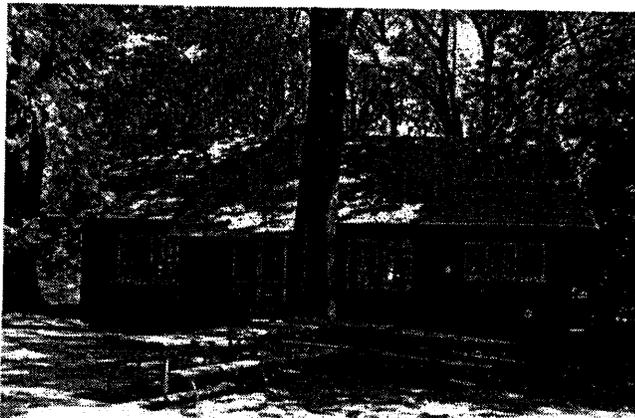
BUILDING NAME: Yosemite Village Girls' Club
STRUCTURE #/ LCS
ID #: VA00057 / 005752
MAP #: Map B, B38
DESCRIPTION: Built 1923. 1 story, wood frame. 27' x 37'. Coursed wood shake siding. Gable roof with wood shingles. Stone and concrete foundation, stone fireplace in recessed front porch.

Yosemite Village Girls' Club, looking south.

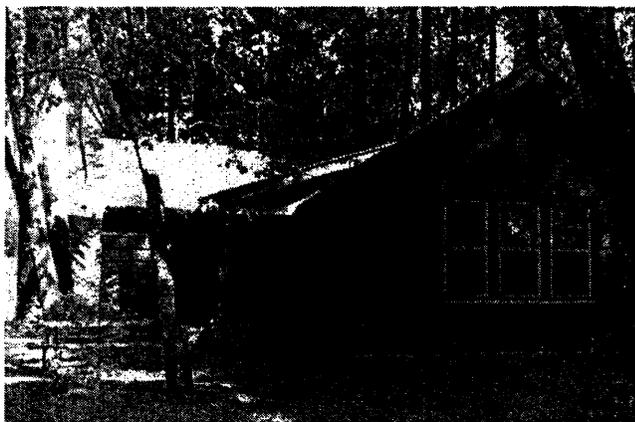
BUILDING NAME: Yosemite Village Girls' Dormitory 59**STRUCTURE #/ LCS****ID #:** VA00059 / 005754**MAP #:** Map B, B40**DESCRIPTION:** Built 1932. 1 story, wood frame, T shaped. 3 room. Drop siding at corners and gable ends, in-fill of decorative wood shakes. Gable roof with wood shingles. Small covered porch with shed roof supported with posts.

Girls' Dormitory 59, facing southwest.

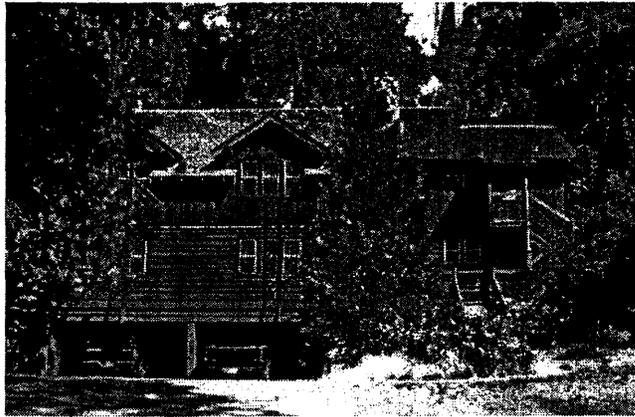
PART III: BUILDING AND STRUCTURE INVENTORY
Supplemental Information for Section 7Yosemite Village Resources
Buildings**BUILDING NAME:** Yosemite Village Apartment Building 60**STRUCTURE #/ LCS****ID #:** VA00060 / 005755**MAP #:** Map B, B41**DESCRIPTION:** Built 1934. 2 story, wood frame, 4-units. Garage in basement. Two apts. on each floor. Horizontal wood siding on ground floor, 2nd is vertical board and batten. Gable ends are shingled with wood. Gable roof with wood shingles. Open gallery porch on each floor. Stone and concrete foundation.

Yosemite Village Apartment 60, facing south.

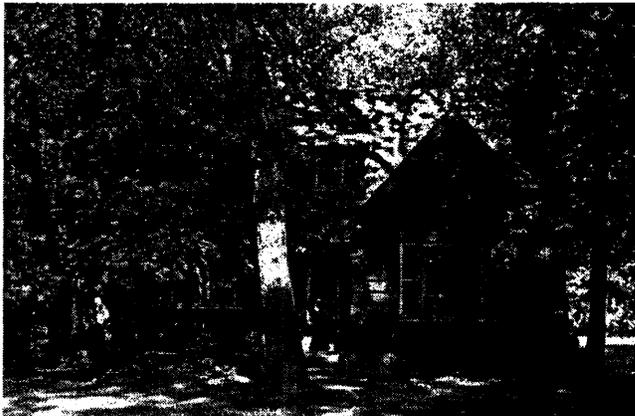
Yosemite Village Residence 61, facing east.

BUILDING NAME: Yosemite Village Residence 61**STRUCTURE #/ LCS****ID #:** VA00061 / 005756**MAP #:** Map B, B42**DESCRIPTION:** Built 1934. 1 story, wood frame. Horizontal wood siding. Gable ends have broad and narrow bands of wood shakes. Gabled roof with wood shingles. Long dormer facing front. Stone and concrete foundation, terrace and chimney.

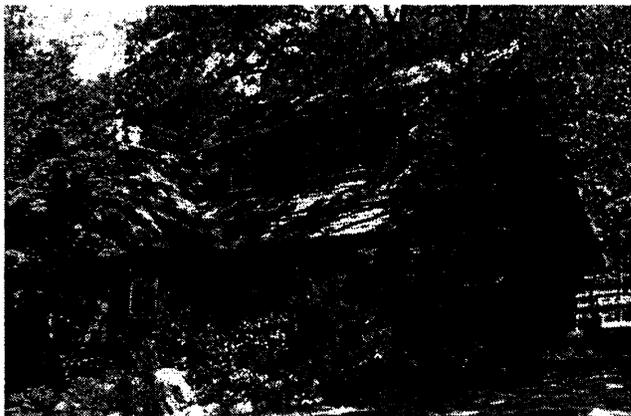
Yosemite Village Residence 63.

Built 1934. 1 1/2 story, wood frame. Horizontal wood siding. Gable ends have wood shake. Gabled roof with wood shingles. Long dormer facing front. Stone and concrete foundation, terrace and chimney.

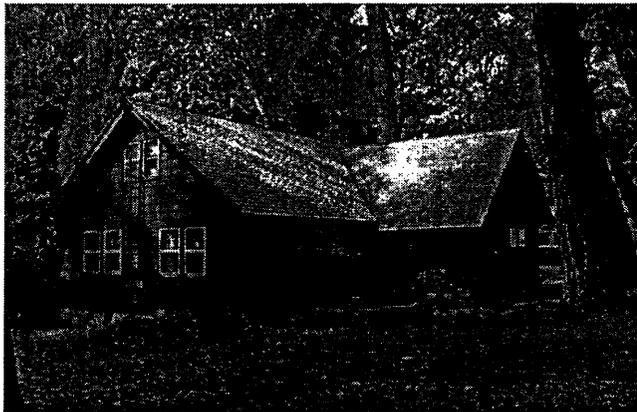
Yosemite Village Residence 67.

BUILDING NAME: Yosemite Village Residence 67
STRUCTURE #/ LCS
ID #: VA00067 / 005760
MAP #: Map B, B46
DESCRIPTION: Built 1940. 1 1/2 story, wood frame. Finished with horizontal lap siding. Gable roof is finished w/ wood shingles. Foundation is stone and concrete. Open porch in front as well stone & concrete terrace. Central stone chimney.

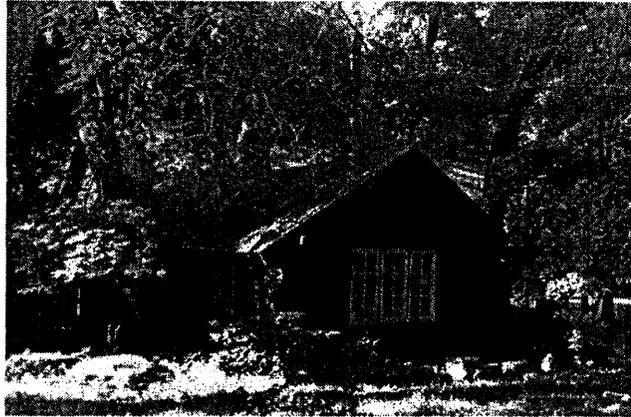
Yosemite Village School Residence 636, facing northeast.

PART III: BUILDING AND STRUCTURE INVENTORY
Supplemental Information for Section 7Yosemite Village Resources
Buildings**BUILDING NAME:** Yosemite Village School Residence 636**STRUCTURE #/ LCS****ID #:** VA00636 / 056011**MAP #:** Map B, B47**DESCRIPTION:** Built 1928. 1 story, wood frame. 45' x 40'. Horizontal wood siding. Gabled roof with wood shingles. Skirt board over foundation. Central stone chimney.

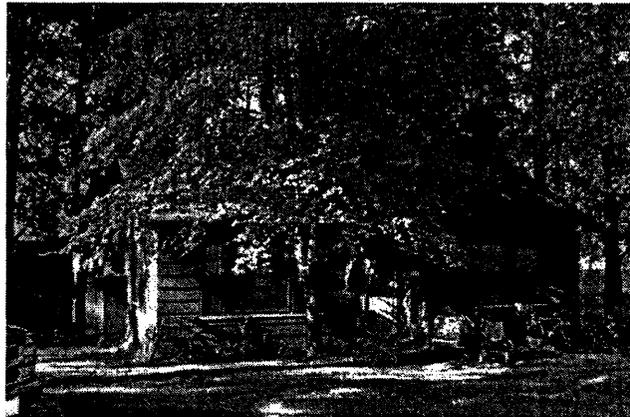
Yosemite Village Residence 637, facing north.

BUILDING NAME: Yosemite Village Residence 637**STRUCTURE #/ LCS****ID #:** VA00637 / 056012**MAP #:** Map B, B48**DESCRIPTION:** Built 1937. 1 1/2 story, wood frame. Horizontal wood siding. Gable roof with intersecting gable over front room, wood shingles. Central stone chimney.

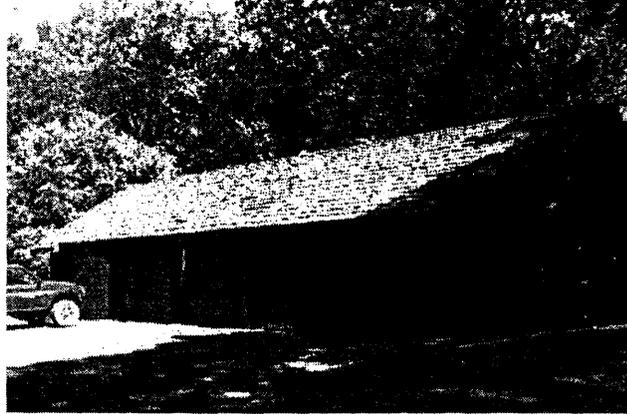
Yosemite Village Garage for Residence 48.

BUILDING NAME: Yosemite Village Garage for Residence 48
STRUCTURE #/ LCS
ID #: VA00302 / 005763
MAP #: Map B, B51
DESCRIPTION: Built 1933. 1 story, wood frame, 5 vehicle, 60' x 20'. Board and batten wainscot, wood shake finish above. Gabled roof with wood shingles. Original doors replaced with overhead metal doors. Located behind residence 48.

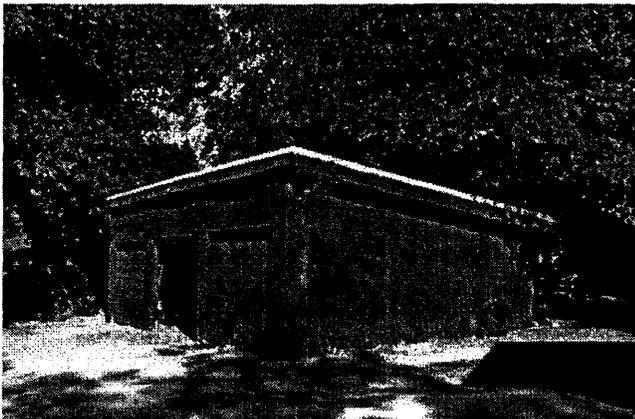
Yosemite Village Garage for Residence 40

DESCRIPTION: Built 1919. 1 story, wood frame, 3 vehicle, 30' x 18'. Coursed wood shakes on back and both ends. Original doors replaced with overhead metal doors. Shed roof with wood shingles, temporarily covered with plastic.

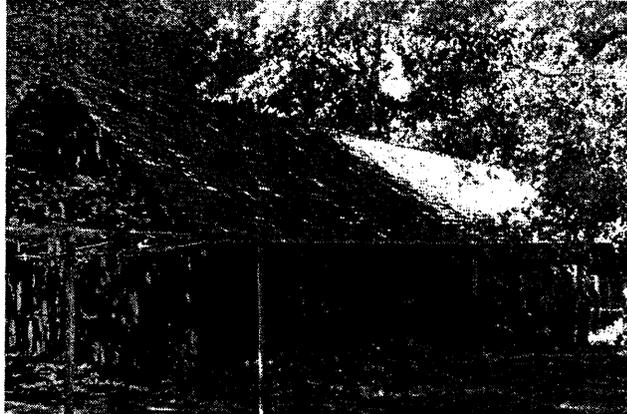
Yosemite Village Garage for Residence 45, facing northeast.

BUILDING NAME: Yosemite Village Garage for Residence 45
STRUCTURE #/ LCS
ID #: VA00308 / 005769
MAP #: Map B, B55
DESCRIPTION: Built 1933. 1 story, wood frame, 5 vehicle, 60' x 21'. Board and batten wainscot, wood shingle finish above. Gabled roof with wood shingles. Original doors replaced with overhead metal doors. Window are fixed sash.

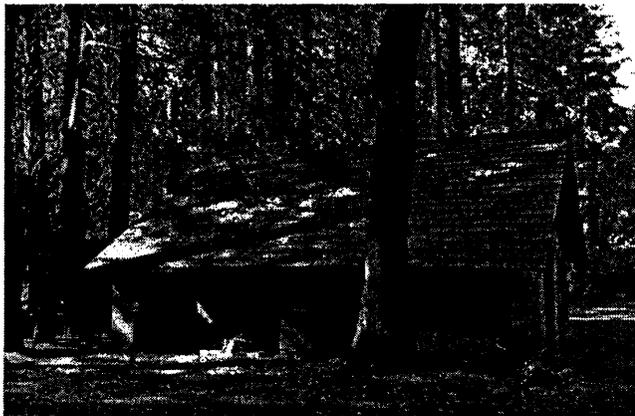
Built 1922. 1 story, wood frame, 2 vehicle, with wood storage shed. Wood storage under extension of gable roof. Wood shakes. Gabled roof with wood shingles. Porch eaves are supported by series of 5 square timber posts resting on conc. pads. Roof is gabled and finished with wood shingles.

Yosemite Village Garage for Residence 12, facing north.

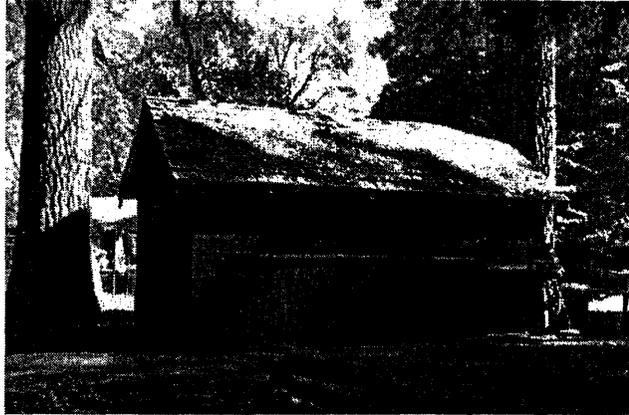
BUILDING NAME: Yosemite Village Garage for Residence 6
STRUCTURE #/ LCS
ID #: VA00313 / 005774
MAP #: Map B, B59
DESCRIPTION: Built 1924. 1 story, wood frame, 1 vehicle. Wood shakes. Gabled roof with wood shingles. Original metal overhead door.

Yosemite Village Garage for Residence 6, facing south.

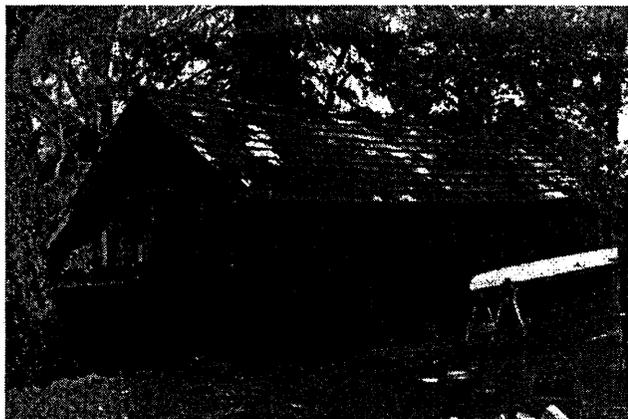
BUILDING NAME: Yosemite Village Woodshed for Residence 21
STRUCTURE #/ LCS
ID #: VA00306 / 005767
MAP #: Map B, B60
DESCRIPTION: Built 1919. 2 room, wood frame, shed with addition. Wood shakes. Gabled roof with wood shingles. Eaves extended for increased wood storage space. Small addition used as playhouse.

Yosemite Village Wood Shed for Residence 21.

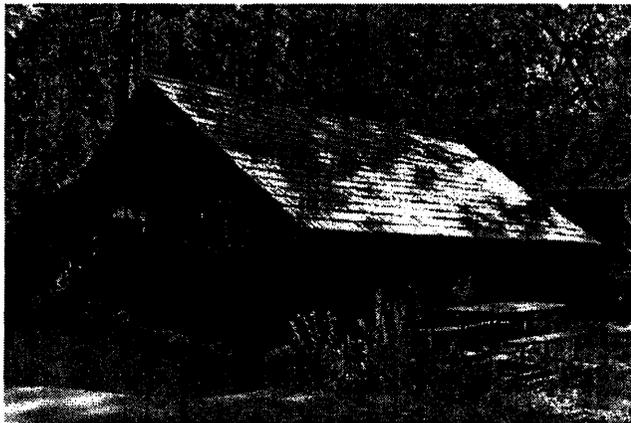
BUILDING NAME: Yosemite Village Woodshed for Residence 8
STRUCTURE #/ LCS
ID #: VA00312 / 005773
MAP #: Map B, B62
DESCRIPTION: Built 1920. 2 room, wood frame, shed with long porches along each side covered by extended eaves of the roof. Gabled roof with wood shingles. Porch eaves are supported by series of 5 square timber posts resting on conc. pads. No foundation.

Yosemite Village Woodshed for Residence 8, facing
southwest.

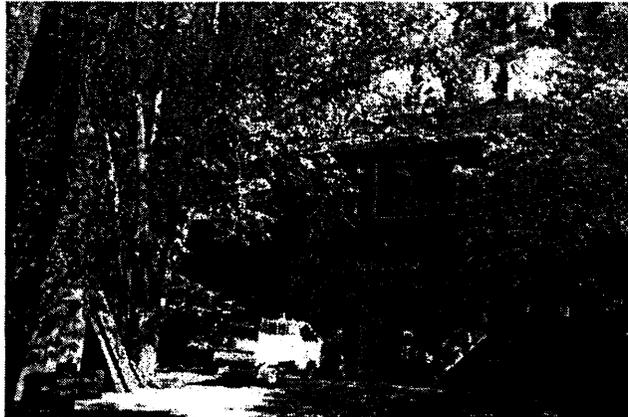
DESCRIPTION: Built 1926. 2-stories & attic. 150'x55'. Frame and concrete construction. Lower story is fireproof w/ thick concrete ceiling forming the 2nd floor, exterior is stone veneer. Arched main entrance. Stone chimney at west end.

Museum Building, southern entrance.

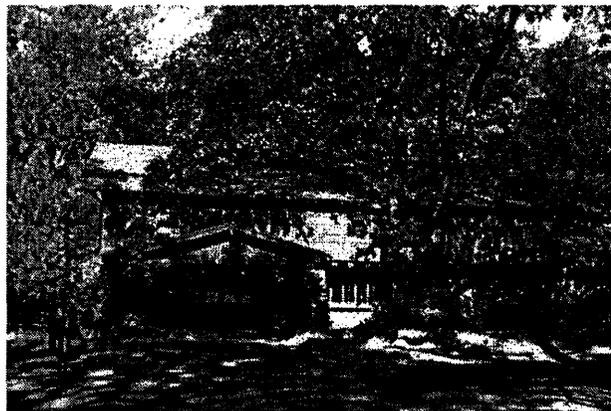
DESCRIPTION: Built 1924. 2 story + attic, wood frame, 102' x 38'. Stone facing on exterior ground floor walls. 2nd floor overhang supported by heavy timbers. Shake siding. Gable entrance porch supported by stone columns. Gabled roof with wood shingles.

Administration building, facing east.

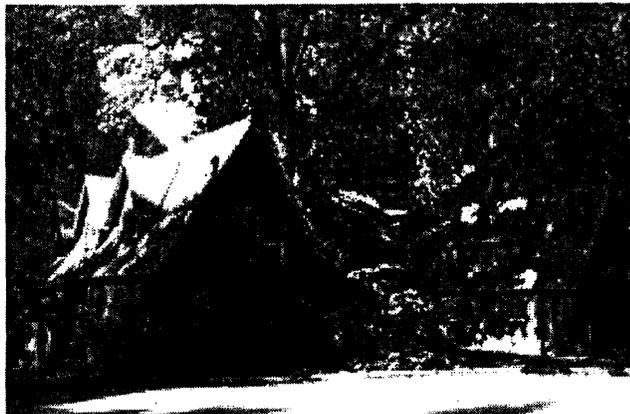
BUILDING NAME: Ranger's Club
STRUCTURE #/ LCS
ID #: VA00056 / 100243
MAP #: Map B, B65
DESCRIPTION: Built 1920. 2 story, wood frame. Granite rubble foundation. U-shaped in plan with small courtyard. Finished with shingles, gable ends are board and batten vertical siding. Decorative jigsaw work throughout. Steep roof pitch, many dormers.

Ranger Club, facing north.

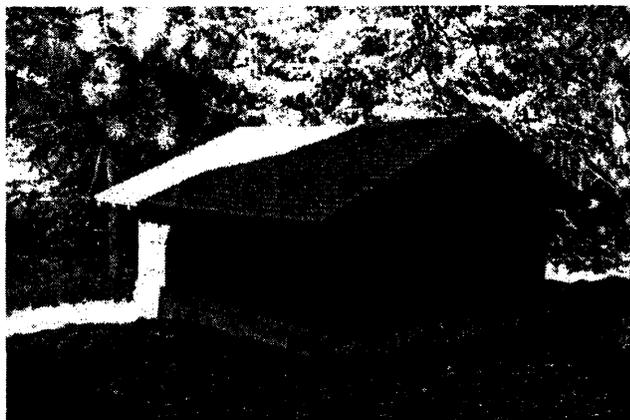
BUILDING NAME: Rangers' Club Transformer House
STRUCTURE #/ LCS
ID #: VA00509 / 055935
MAP #: Map B, B66
DESCRIPTION: Built 1920. 1 story, 12' x 12'. Log frame on stone wall. Sided with vertical boards with perforated design. Gabled roof with wood shingles.

Rangers' Club Transformer House, facing north.

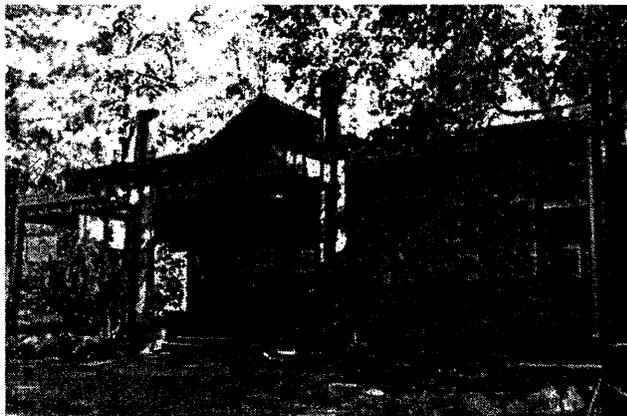
Built ca. 1925. 2, 1 story, wood frame buildings. South structure is gallery, north structure is private residence. Gallery is square with L shaped deck. Cross-shaped roof with stone chimney. Residence is short and square. Wood shingles, hipped roof.

Best Studio, facing south.

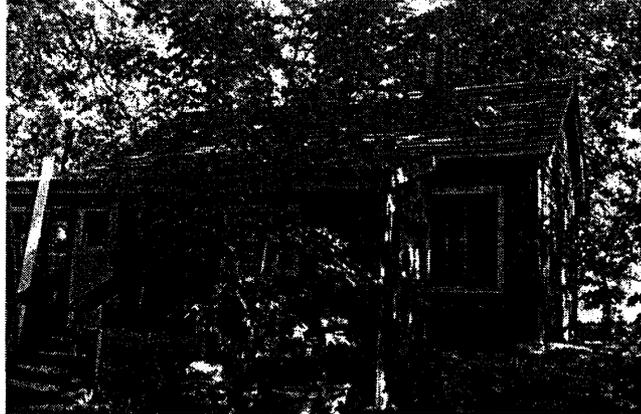
BUILDING NAME: Ansel Adams Residence
STRUCTURE #/ LCS
ID #: VA00902 / 055938
MAP #: Map B, B69
DESCRIPTION: Built ca. 1925. Rustic wood frame. Shingled walls and gable roof. Originally a duplex, converted into a single family house.

Ansel Adams Residence.

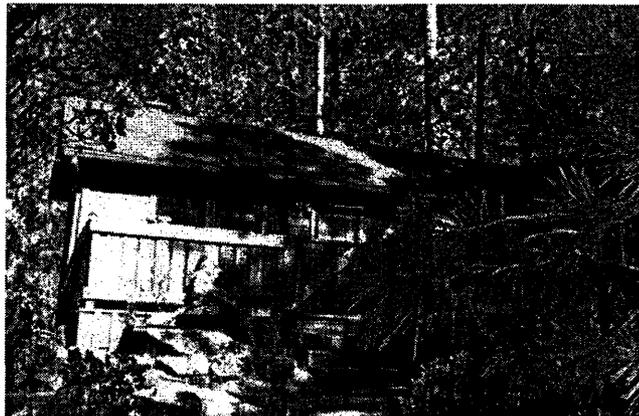
BUILDING NAME: Ansel Adams Duplex Residence.
STRUCTURE #/ LCS
ID #: VA00904 / 055940
MAP #: Map B, B70
DESCRIPTION: Built 1925. 1 story, wood frame, T shape, rustic. Shake siding. Wood casement windows. Gable roof finished with asphalt shingles. Stone chimney. Trellis covered porch with board railing.

Ansel Adams Duplex Residence.

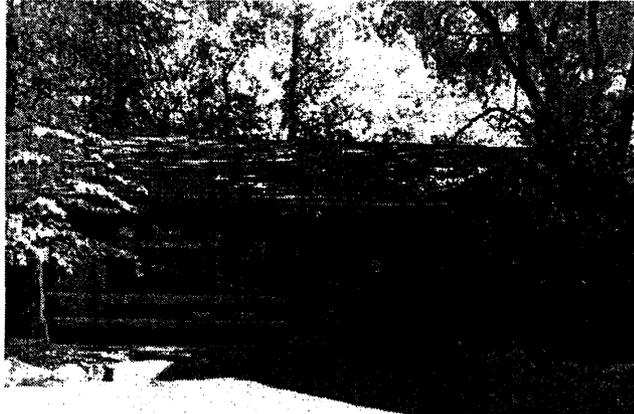
PART III: BUILDING AND STRUCTURE INVENTORY
Supplemental Information for Section 7Yosemite Village Resources
Buildings**BUILDING NAME:** Pohono Indian Studio**STRUCTURE #/ LCS****ID #:** VA01005 / 005786**MAP #:** Map B, B71**DESCRIPTION:** Built 1925. Peeled log frame, 30' x 40'. Wood shingle in-fill painted brown. L shaped with covered porch on S elevation. Gable roof supported by log rafters.

Pohono Indian Studio, facing south.

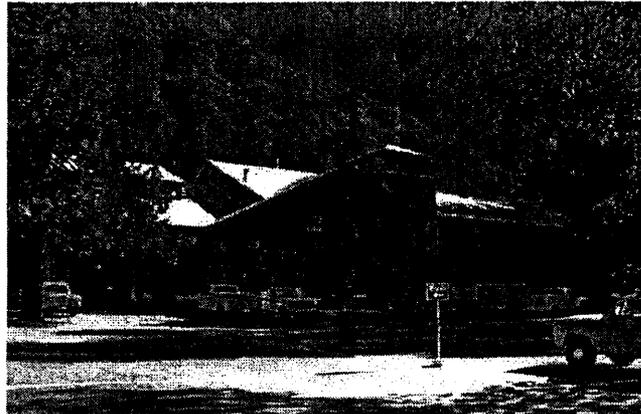
Built 1935. Reinforced concrete walls. 260' long at West end. 1 story portion is approx. 70' wide, rest is 75' long with 2 stories, approx. 60' wide. Roof supported by steel trusses, concrete quoining, cast concrete eave molding, wood grain pattern on ext. walls.

Yosemite Valley Group Utility Building, facing south.

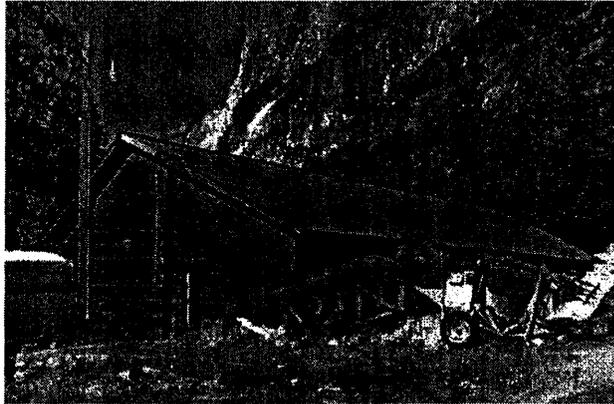
BUILDING NAME: Yosemite Valley Group Utility Area Equipment Shed (516)
STRUCTURE #/ LCS
ID #: VA00516 / 059789
MAP #: Map B, B81
DESCRIPTION: Built 1921. Wood frame. 25' x 91'. 9-stall garage, now used as shop for equipment, electronics, and road sign storage. Gable roof.

Yosemite Valley Group Utility Area Equipment Shed (516).

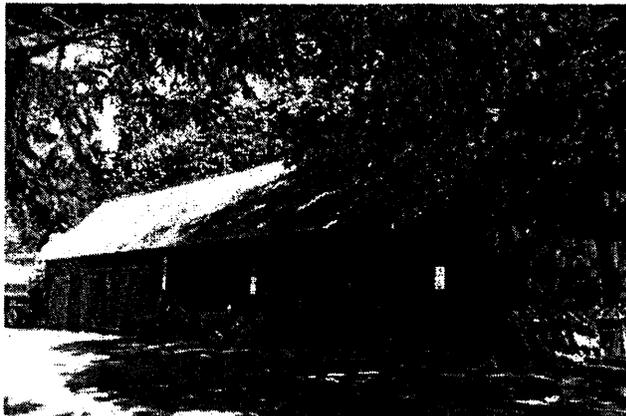
BUILDING NAME: Yosemite Valley Group Utility Area Equipment Shed (519)
STRUCTURE #/ LCS
ID #: VA00519 / 059791
MAP #: Map B, B83
DESCRIPTION: Built 1921. 25'x91', 9-stall garage now used as signs and roads storage. Wood and pole frame, gable roof.

Yosemite Valley Group Utility Area Equipment Shed (519), facing south.

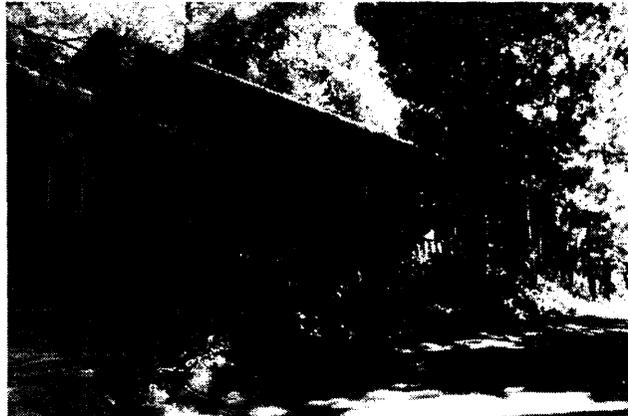
DESCRIPTION: Built 1929. 1 story with partial basement. L shaped plan with addition on west end. Board & batten siding. Raised stone & concrete foundation. Stone entrance porch & steps with shed roof. Gable roof with stone chimney. Original shingles have been replaced with asphalt.

Lewis Memorial Hospital (Medical Clinic), facing southwest.

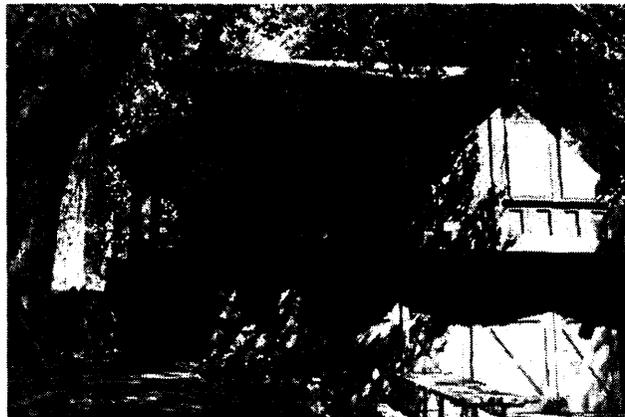
DESCRIPTION: Built 1931. Modified 6-stall, wood frame garage with 2nd floor apt. Stone & concrete foundation. 2nd floor sided with vertical planks. Gable roof with cross gables & brackets. Side entrance porch with stone steps. Hipped gable & entrance porch on east end.

Nurses' Quarters and Garage, facing south.

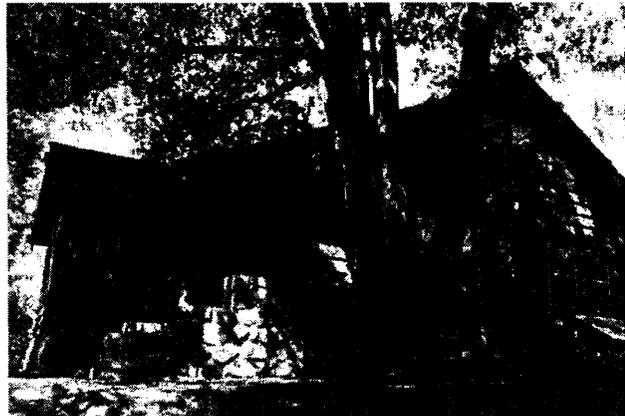
BUILDING NAME: Yosemite Village Residence 65
STRUCTURE #/ LCS
ID #: VA00065 / 056014
MAP #: Map B, B100
DESCRIPTION: Built 1939. 1 ½ story, wood frame. Horizontal wood siding. Gabled roof with wood shingles. Dormer. Open porch at entry. Stone and concrete foundation, terrace and chimney. Large stone steps to house.

Yosemite Village Residence 65, facing southeast.

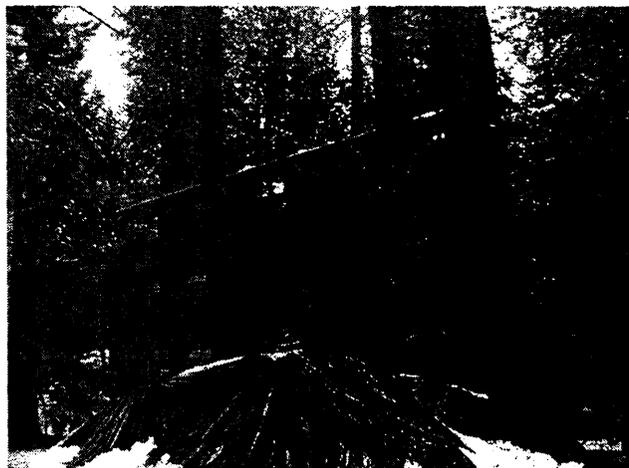
Built 1930s. Three story, wood frame. Large rectangular floor plan with 2 tapering extensions each end. Corrugated metal roofing. Siding: T&G, panel wide-board at the top sections, drop siding 6' and below. 4 upper corner porches. Concrete foundation.

Lower Tecoya Dorm E, looking southwest.

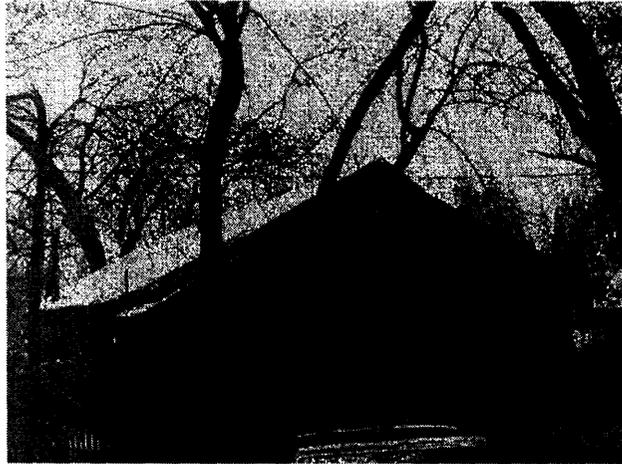
Built 1925-1930. Date of modifications unknown. 1 story, wood frame. Rectangular floor plan with corner cut-out. Cut-out creates entry. Uneven pitch gable roof; asphalt shingles. South side is shallower pitch. Regular gable pitch extends over porch entry. Sugarpine shake siding. 3 tall, wood casement windows front. Non-original, clad 4 and 8-lite windows. Drop siding skirt.

Lower Tecoya Residence 115, looking northwest.

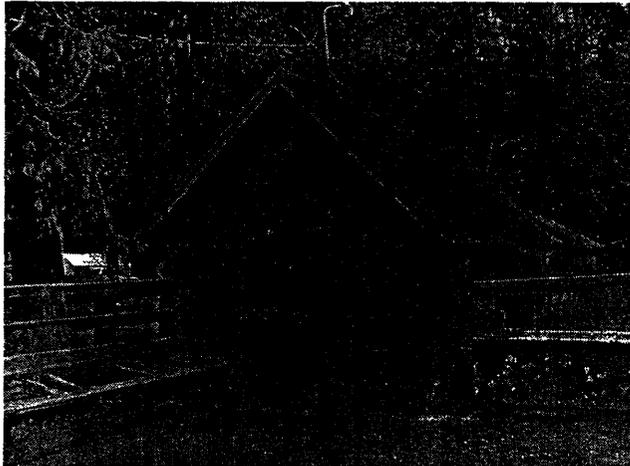
PART III: BUILDING AND STRUCTURE INVENTORY
Supplemental Information for Section 7Yosemite Village Resources
Buildings**BUILDING NAME:** Lower Tecoya Residence 114**STRUCTURE #/ LCS****ID #:** YVE114 / 207475**MAP #:** Map B, B111**DESCRIPTION:** Built 1925-1930. Originally a one story, gable roofed structure; now 2 story wood frame. Main roof, west & east wing- gabled; asphalt shingles. North wing - shed; asphalt shingles. West gable includes entry roof extension. Sugarpine shake siding. Sugarpine shake skirt. Central brick chimney. Rear metal chimney. Date of additions unknown.

Lower Tecoya Residence 114, looking northwest.

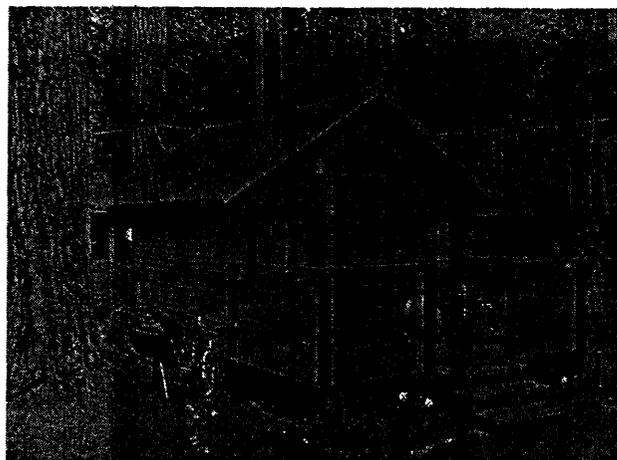
BUILDING NAME: Lower Tecoya Residence 113**STRUCTURE #/ LCS****ID #:** YVE113 / 059816**MAP #:** Map B, B112**DESCRIPTION:** Built 1920. 1 story, wood & log frame. T floor plan. Gable roof; asphalt shingles. Board & batten siding. Half log and 2x detailing. Gable roof entry, log frame & detail.

Lower Tecoya Residence 113, looking northwest.

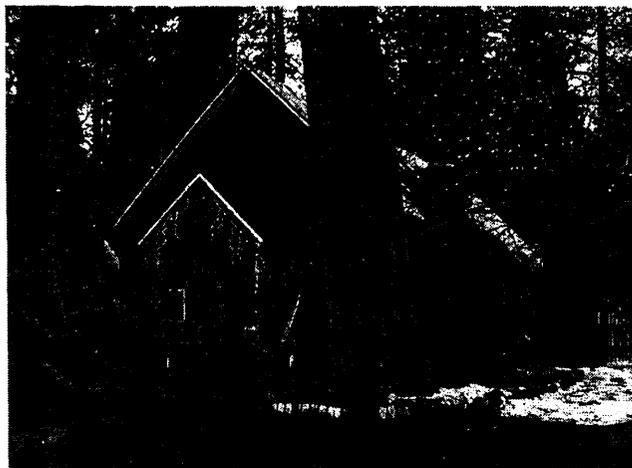
DESCRIPTION: Built 1922-1924. 1 story, wood frame. Stubby L floor plan. Gable roof; asphalt shingles. Field stone facing to top plate, board and batten at gable ends. Non-original clad, 8-lite slider windows. Gable roof entry, log frame & detail.

Lower Tecoya Residence 110, looking west.

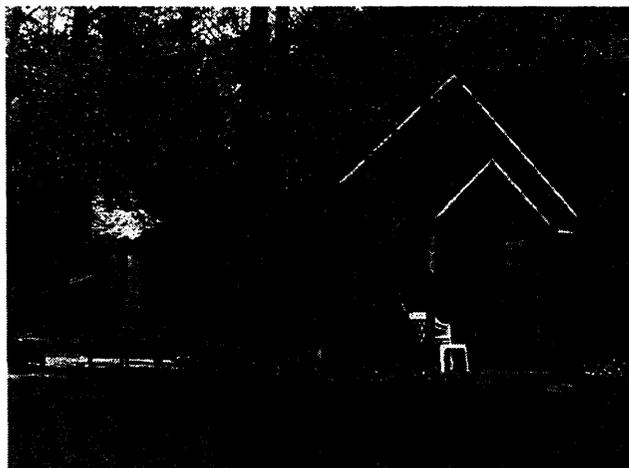
DESCRIPTION: Built 1922-1924. 1 story, wood frame. Stubby L floor plan. Gable roof; asphalt shingles. Horizontal board and chamfer rail siding. Non-original clad, 8-lite slider windows. Gable roof entry, 4x4 frame with spaced, vertical boards at mini-gable. Side entry door on N side.

Lower Tecoya Residence 109, looking northwest.

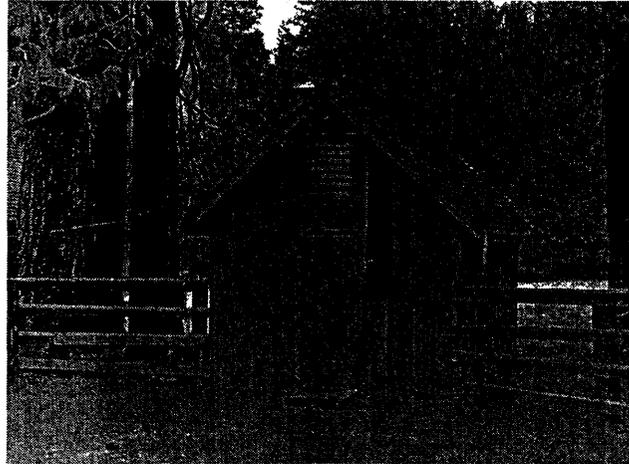
BUILDING NAME: Lower Tecoya Residence 108
STRUCTURE #/ LCS
ID #: YVE108 / 059811
MAP #: Map B, B117
DESCRIPTION: Built 1922-1924. Hollow-tile construction (tiles are ~ 5"x 10") Stubby L floor plan. Gable roof; asphalt shingles. Non-original clad, 8-lite sliders. Concrete chimney. Gable roof entry, 4x4 frame with spaced, vertical boards at mini-gable.

Lower Tecoya Residence 108, looking west.

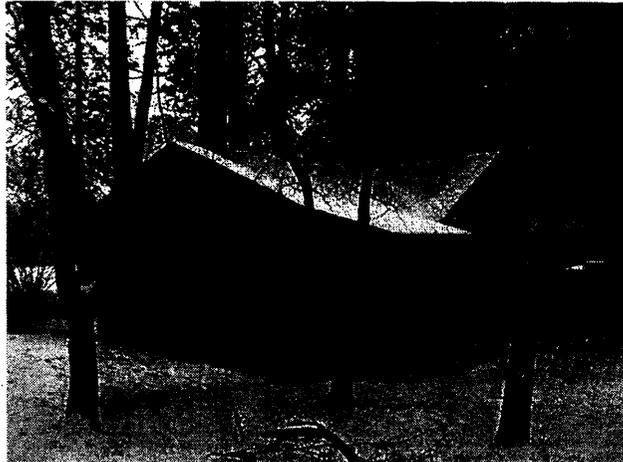
BUILDING NAME: Lower Tecoya Residence 99
STRUCTURE #/ LCS
ID #: YVE099 / 059819
MAP #: Map B, B123
DESCRIPTION: Built circa 1920-1930s. Similar to 98, date of addition unknown. 1 story, wood frame. Rectangular plan. Cross-gable roof; asphalt shingles. Extended top plate beams. Sugarpine shake siding. Drop siding skirt. Bay window, front. Also non-original clad 8-lite DH windows. Small attached storage shed, rear.

Lower Tecoya Residence 99, looking southeast.

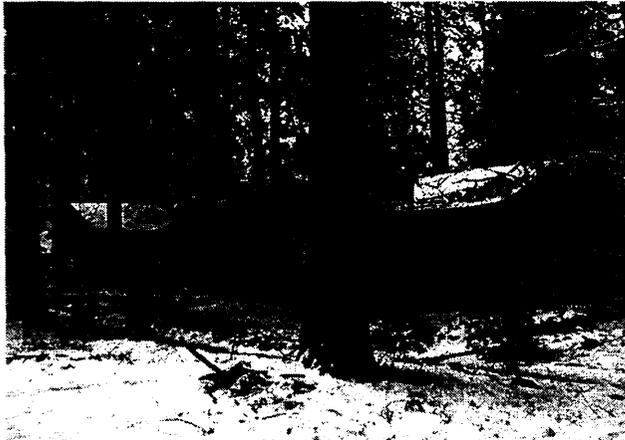
DESCRIPTION: Built 1925-1930. 1 story, wood frame. Modified I floor plan. 5 unit apartment building. Gable roofs; asphalt. Board & batten, sugarpine shake siding. Sugarpine shake siding likely was original siding. Small, varying shed roofed porches and entryways. Metal gutters. Concrete footings. Stone lined walkways, front. Same layout as #86-91.

Lower Tecoya Residences 92-97, looking east.

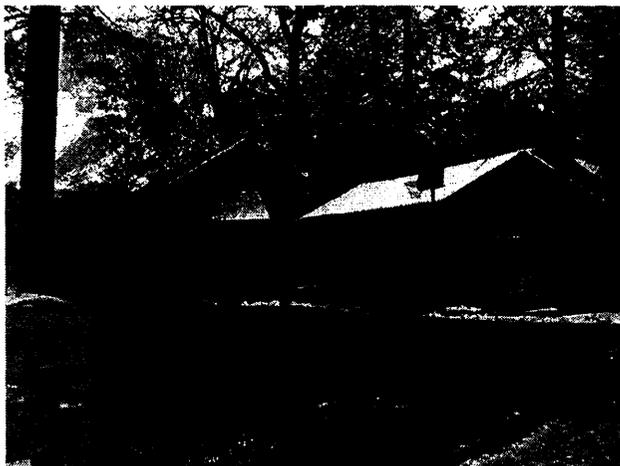
Built 1920. 1 story, wood frame. 3 bay. Cape roof; asphalt shingles. Sugarpine shake siding. Original bi-fold doors; Herringbone detail. Concrete foundation. Located behind Lower Tecoya Residences #116, 117.

Lower Tecoya Garage (200A), on the right, behind Residence 116 and 118, looking east.

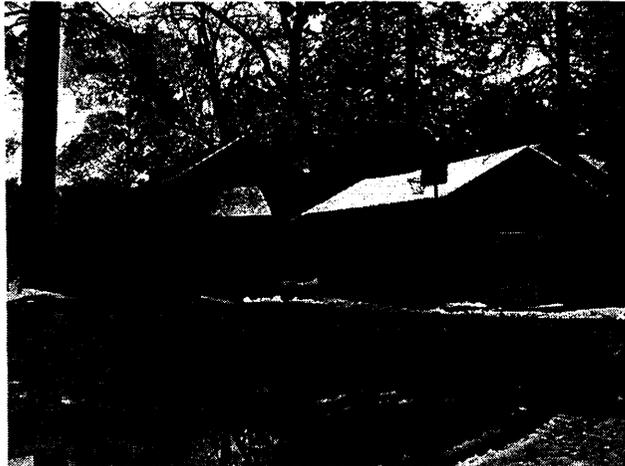
BUILDING NAME: Lower Tecoya Garage (200B)
STRUCTURE #/ LCS
ID #: YVE200B / 059827
MAP #: Map B, B129
DESCRIPTION: Built 1920. 1 story, wood frame. 2 bay. Cape roof; asphalt shingles. Sugarpine shake siding. Replacement doors; plywood. Side door, N. Concrete foundation. Located behind Lower Tecoya Residences #116, 117.

Lower Tecoya Garage (200B), on the left, behind Residence 116 and 118, looking east.

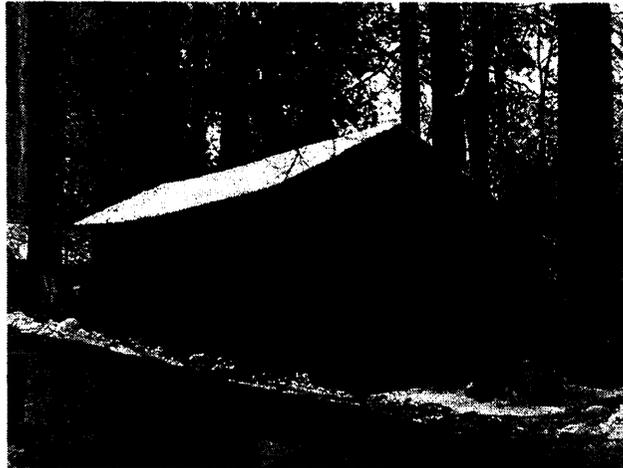
BUILDING NAME: Lower Tecoya Garage (200G)
STRUCTURE #/ LCS
ID #: YVE200G / 059830
MAP #: Map B, B131
DESCRIPTION: Built 1920. 1 story, wood frame. 3 bay. Cape roof; asphalt shingles. Sugarpine shake siding. Original bi-fold doors; Herringbone detail. 2 side doors, N & S. Concrete foundation. Located behind Lower Tecoya Residences #108, 109.

Lower Tecoya Garage (200G), looking northwest.

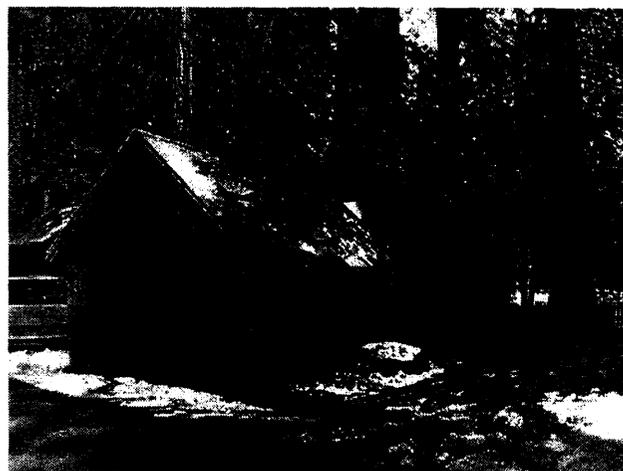
BUILDING NAME: Lower Tecoya Garage (200H)
STRUCTURE #/ LCS
ID #: YVE200H / 059831
MAP #: Map B, B132
DESCRIPTION: Built 1923. Gable roof, asphalt shingles. Sugarpine shake siding. Full garage to rear with small ground to eave window protrusion. Herringbone doors.

Lower Tecoya Garage (200H), looking northeast.

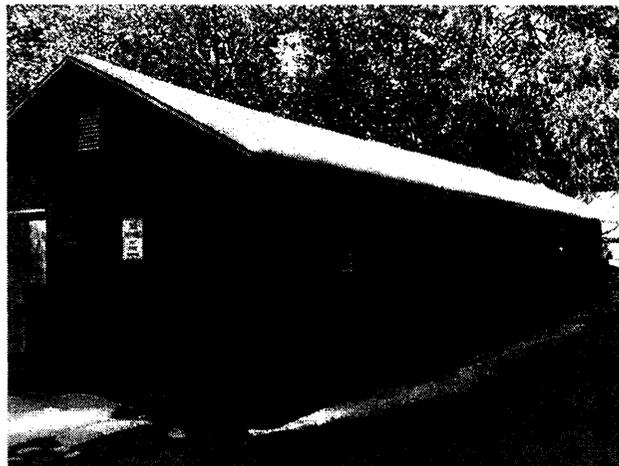
BUILDING NAME: Lower Tecoya Garage (Maintenance #1)
STRUCTURE #/ LCS
ID #: YVE300A / 059832
MAP #: Map B, B135
DESCRIPTION: Built 1920s. 1 story, wood frame. 5-bay. Original bi-fold swing doors with herringbone detail. Gable roofs with asphalt shingles. ~12' x 50'.

Lower Tecoya Garage (Maintenance #1), looking west.

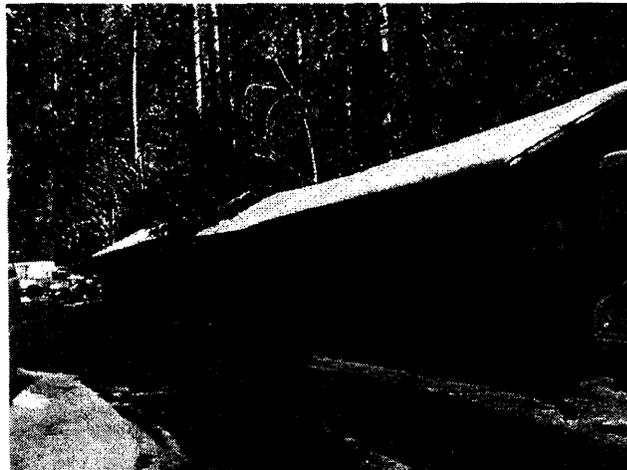
Built 1920s. 1 story, wood frame. Original bi-fold swing doors with herringbone detail. Gable roofs with asphalt shingles. ~12' x 50'.

Lower Tecoya Garage (Maintenance #2) (left) and Lower Tecoya Garage (Maintenance #3) (right), looking north..

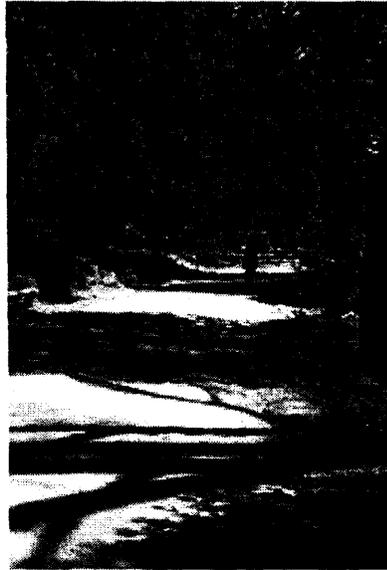
Middle Tecoya Road

Built ca. 1930-1945. Loop road through Middle Tecoya Residences. Middle Tecoya Residences were built circa 1940.

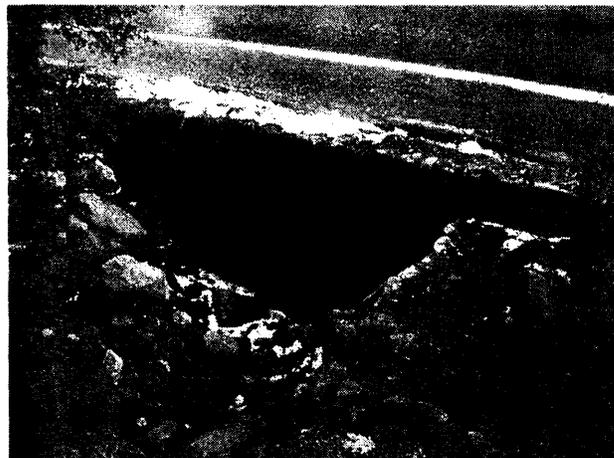
Indian Canyon Creek Bridge #2

Built ca. 1930s. Rough granite, low profile bridge/culvert located to N side of Lower Tecoya residences. Crossed by Ahwahanee Road.

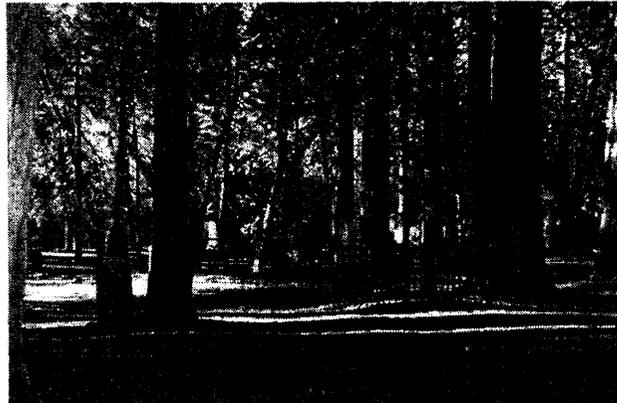
Yosemite Pioneer Cemetery.

Includes individual grave markers, a rock wall structure, and paths.

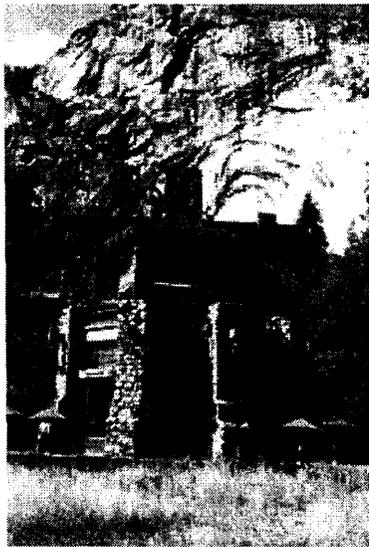
Ahwahnee Hotel, with Royal Arches behind

DESCRIPTION: Built 1927. Steel frame and concrete. Stone facing, and horizontal wood siding. 150,000 sq. ft. 3 wings form Y shaped floor plan. Multiple slate hip and gable roofs. 95 guest rooms and 3 large public rooms. Wings around perimeter are 2 to 3 stories. Center core is six stories. Exterior massing is irregular, asymmetrical and broken up with numerous balconies and terraces.

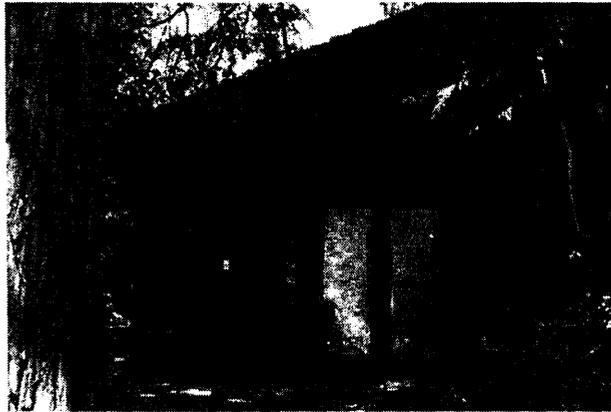
Ahwahnee Hotel Guest Cottage 722, facing south.

BUILDING NAME: Ahwahnee Hotel Guest Cottage 720-723
STRUCTURE #/ LCS
ID #: AHL303 / 055577
MAP #: Map C, B4
DESCRIPTION: Built 1928. Wood frame. 4-plex cottage, rectangular. Redwood lap siding, gabled roof with large overhanging eaves. Small entrance abutments at each length end with gabled roofs that mimic main hotel's roof. Carved Indian motifs appear as decorative details.

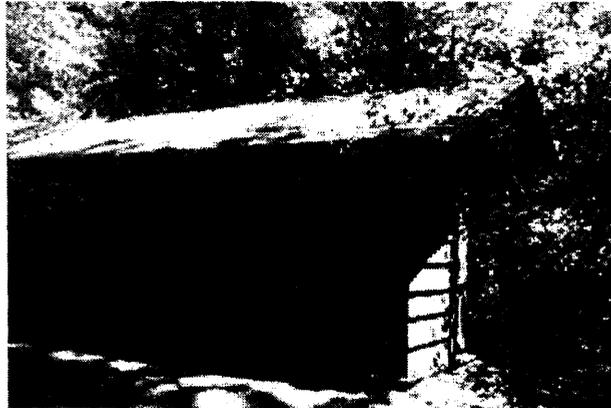
Ahwahnee Hotel Guest Cottage 705, facing southeast.

PART III: BUILDING AND STRUCTURE INVENTORY
Supplemental Information for Section 7**Ahwahnee Hotel Resources**
Buildings**BUILDING NAME:** Ahwahnee Hotel Guest Cottage 704/705**STRUCTURE #/ LCS****ID #:** AHL305 / 059750**MAP #:** Map C, B6**DESCRIPTION:** Built 1928. Wood frame. Duplex cottage. Ground-hugging, rectangular. Redwood siding, gabled roof with large overhang. Split shake roof shingles. 10-lite entrance doors. Craftsman details. Stone terrace. Carved Indian motifs appear as decorative details.

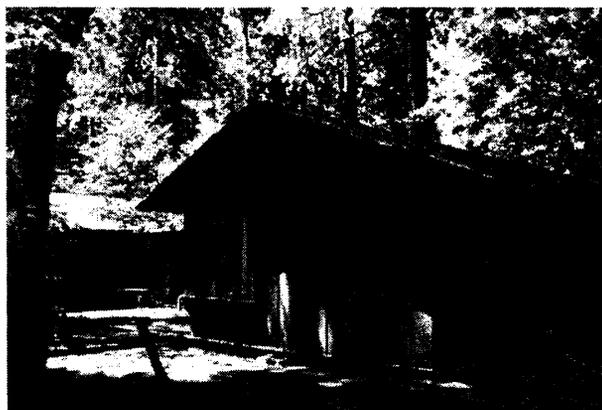
Ahwahnee Hotel Guest Cottage 716, facing northeast.

BUILDING NAME: Ahwahnee Hotel Guest Cottage 715/719**STRUCTURE #/ LCS****ID #:** AHL308 / 059753**MAP #:** Map C, B9**DESCRIPTION:** Built 1928. I shaped, 5-plex cottage. Redwood lap siding, gabled roof with large overhanging eaves. Split shake roof shingles. 10-lite entrance doors. Craftsman details. Stone terrace. Carved Indian motifs appear as decorative details.

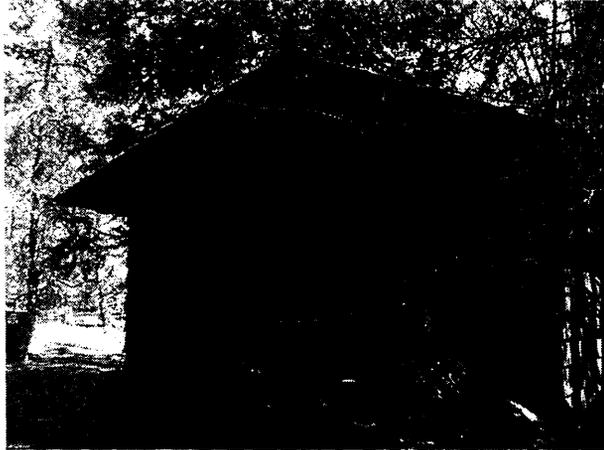
Ahwahnee Hotel Guest Cottage Linen Building,
looking northeast.

PART III: BUILDING AND STRUCTURE INVENTORY
Supplemental Information for Section 7Ahwahnee Hotel Resources
Buildings**BUILDING NAME:** Ahwahnee Hotel Guest Cottage Linen Building**STRUCTURE #/ LCS****ID #:** AHS / 055629**MAP #:** Map C, B10**DESCRIPTION:** Built circa 1928. 1 story, wood frame. ~14' x 20'. Modified rectangle. Gable roof with partial extension N side; thick cedar shingles. Drop siding. Vertical wide-board on N extension and at centers of each end. Concrete foundation. Open eaves with fancy rafter end detail. One door. Used to store linens and cots.

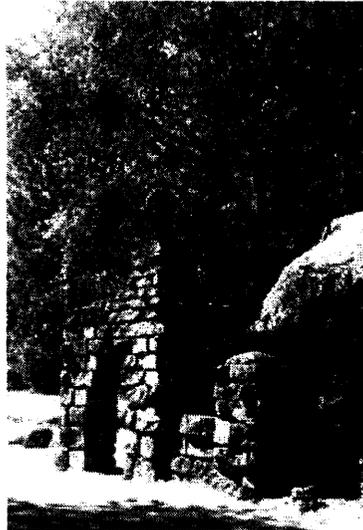
Ahwahnee Hotel Gate Lodge and Post, facing southeast.

DESCRIPTION: Built 1930. Irregular stone. Entering the grounds the gate house is to left, post to right. Gate house, 16' high, is built into very large boulder. Two arched entries with a pyramidal roof. Iron hotel sign mounted on top. Gate Post is a stone column 8' tall by 3' square.

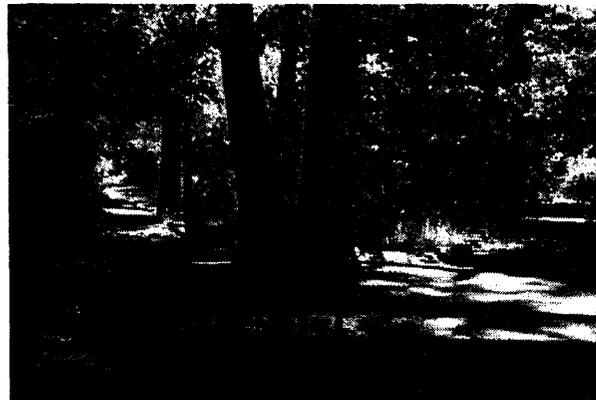
Ahwahnee Hotel Paths Leading to Guest Cottages.

Built 1928. Path connect hotel with the cottage area. Asphalt paths edged with low-cut logs.

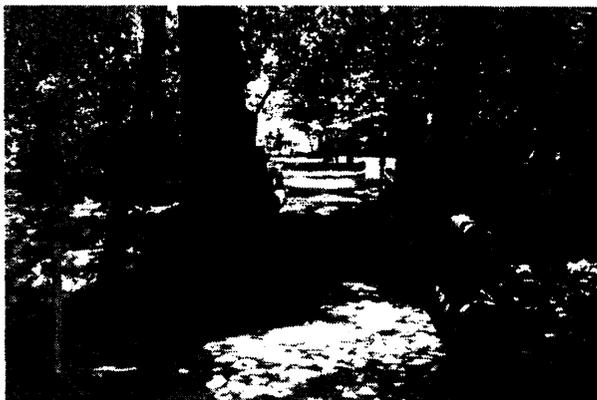
Ahwahnee Hotel Footbridge to Guest Cottages, looking east.

STRUCTURE NAME: Ahwahnee Hotel Footbridge to Guest Cottages
STRUCTURE #/ LCS
ID #: BR00101 / 055482
MAP #: Map C, S6
DESCRIPTION: Built 1930. Constructed of large logs. Painted brown. ~ 10 feet long. Seats built into bridge on both sides, in style of Adirondack chairs.

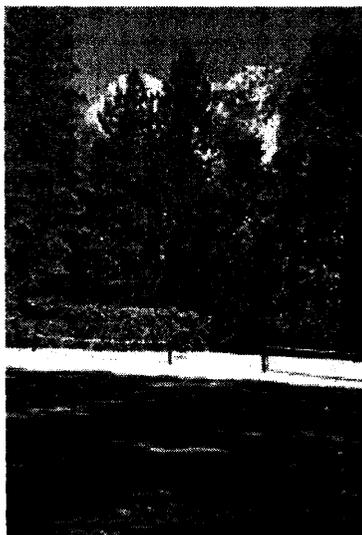
Ahwahnee Hotel Tennis Courts, looking toward the northeast.

STRUCTURE NAME: Ahwahnee Hotel Tennis Courts
STRUCTURE #/ LCS
ID #: AHV / 055481
MAP #: Map C, S10
DESCRIPTION: Built 1928. Two tennis courts. Newly resurfaced. Surrounded by chain link fence. Also a handball wall and stone viewing terrace. Located in grove of trees on SW corner of property.

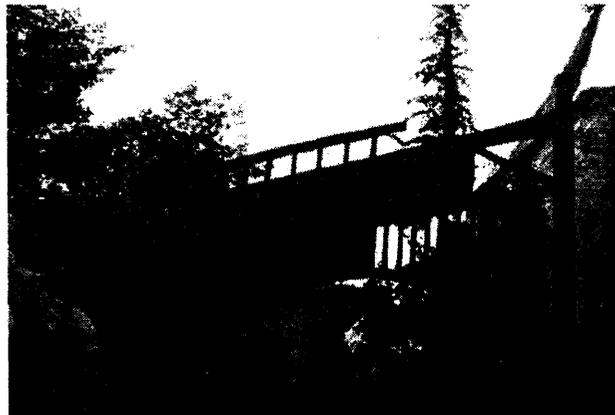
Camp Curry Entrance Gate.

STRUCTURE NAME: Camp Curry Entrance Gate
STRUCTURE #/ LCS
ID #: GR00003 / 055960
MAP #: Map D, S545
DESCRIPTION: Built 1914. Rough style sign, 20' high. Unpeeled log supports with the words "CAMP CURRY" and "WELCOME" spelled out in unpeeled saplings. Fretwork, also in unpeeled saplings, adds rustic decoration to the sign.
